**MARYLAND HISTORICAL TRUST  
DETERMINATION OF ELIGIBILITY FORM**

Property Name: Worden House Inventory Number: CARR-1677  
Address: 4550 Francis Scott Key Highway City: Taneytown Zip Code: 21787  
County: Carroll USGS Topographic Map: Taneytown  
Owner: Herbert and Karen Worden Is the property being evaluated a district? ☐ yes  
Tax Parcel Number: 264 Tax Map Number: 10 Tax Account ID Number: 031775  
Project: Worden - Galt N. Agency: Federal Communications Commission  
Site visit by MHT staff: ☒ no ☐ yes Name: \_\_\_\_\_ Date: \_\_\_\_\_  
Is the property is located within a historic district? ☐ yes ☒ no

NR-ELIGIBILITY REVIEW FORM

Worden House

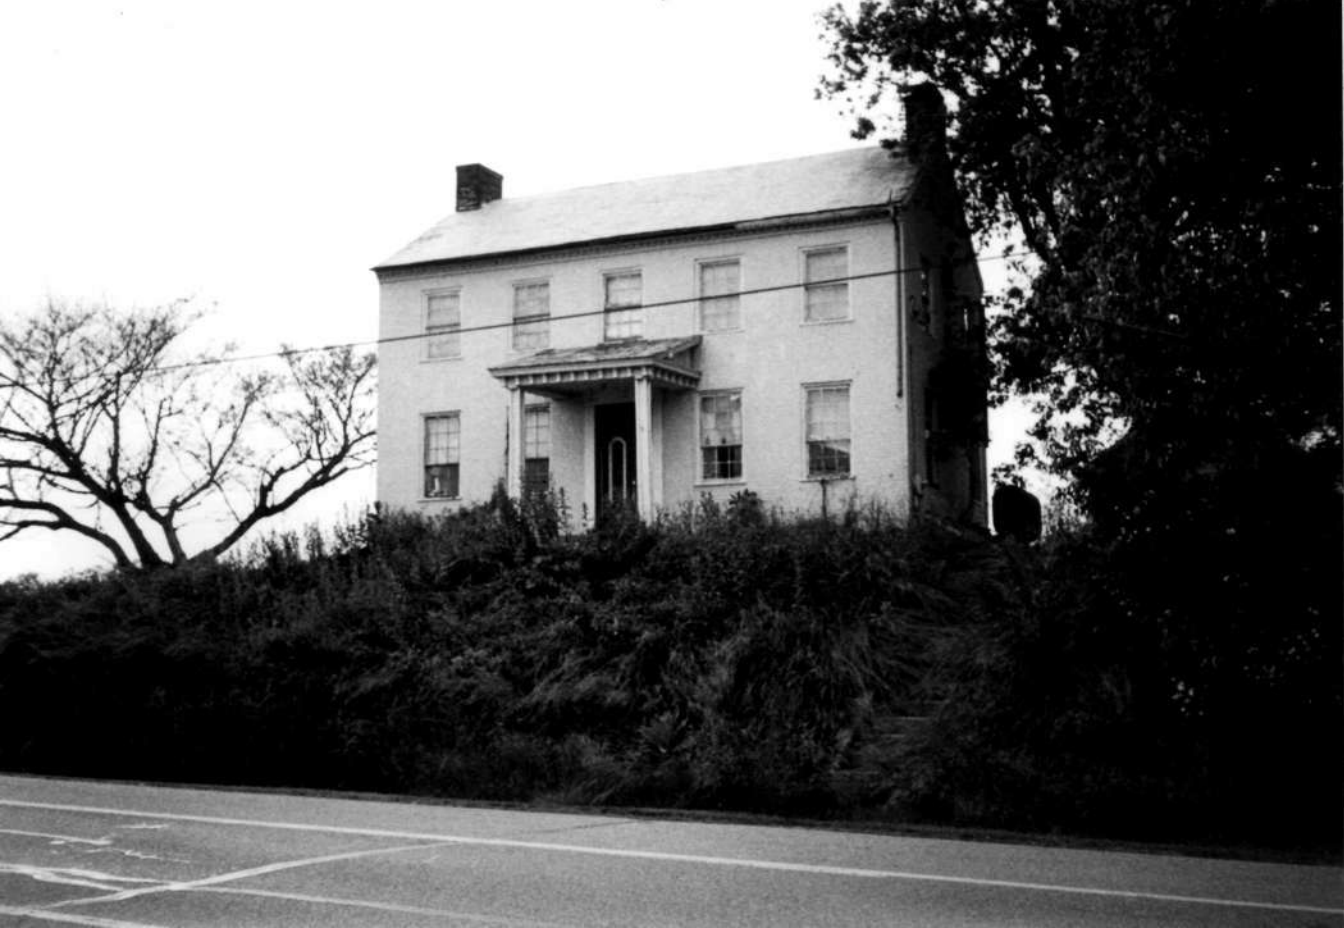
1/6

WORDEN PROPERTY - MAIN HOUSE, SOUTH ELEVATION  
CARROLL CO., MARYLAND

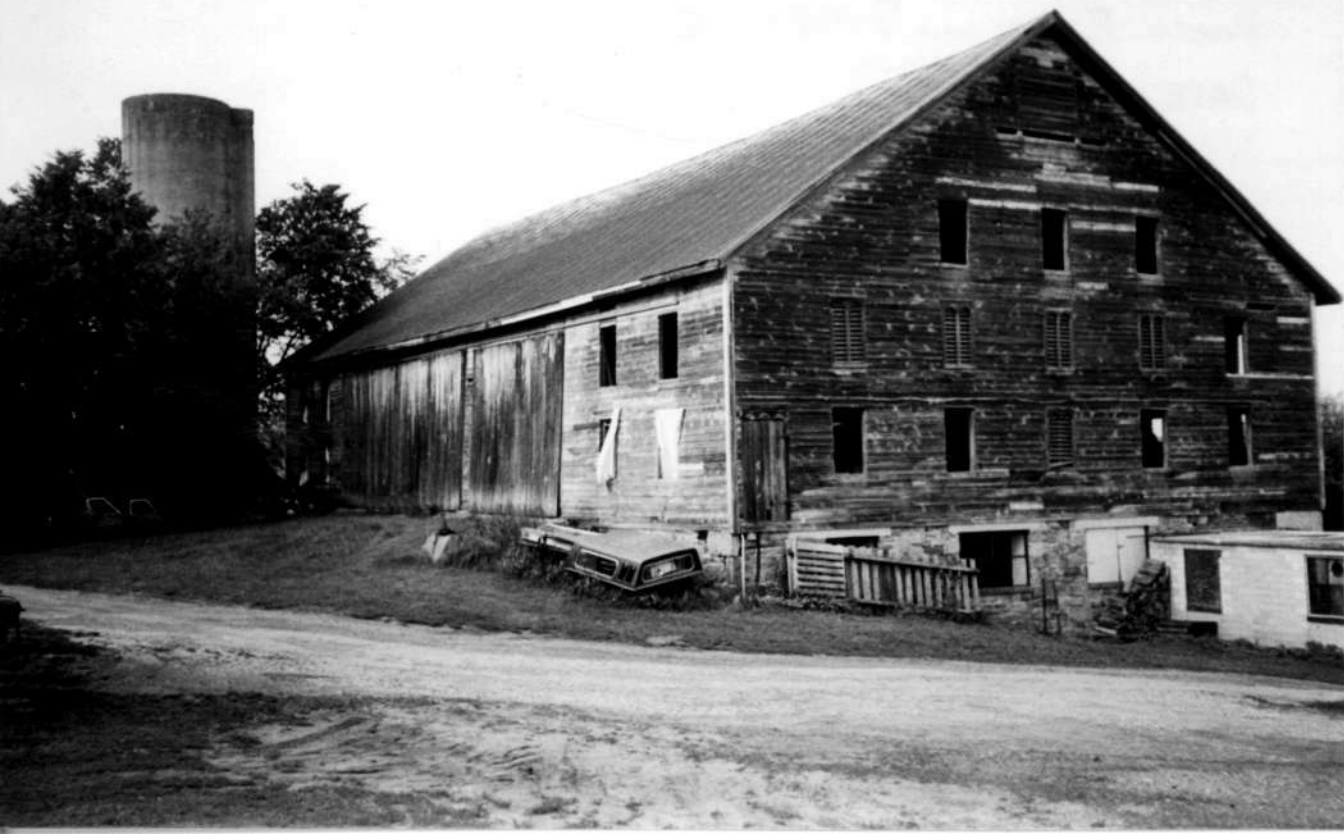
2/0

and concrete masonry units. The superstructure of the barn is of timber framing, with horizontal wood siding and a standing seam metal roof. The barn has not been well-maintained; the wood exterior is dark and weathered. The base of the barn is partially constructed of stone and partially of concrete masonry units. This lower floor contains the only glass windows in the structure. The fenestration in the upper floors is a regular pattern of vertically-disposed rectangular openings, many of which are just that--holes in the wall. There are examples on the second floor level particularly, of paired wooden shutters with horizontal louvers and semicircular rounded tops. One expects that these shutters once filled all of the "window" openings in the barn walls. Along the side of this structure, opposite of the highway is a concrete silo approximately fifty to sixty feet tall. The silo is currently surrounded by junk and debris.

WORDEN PROPERTY - BARN

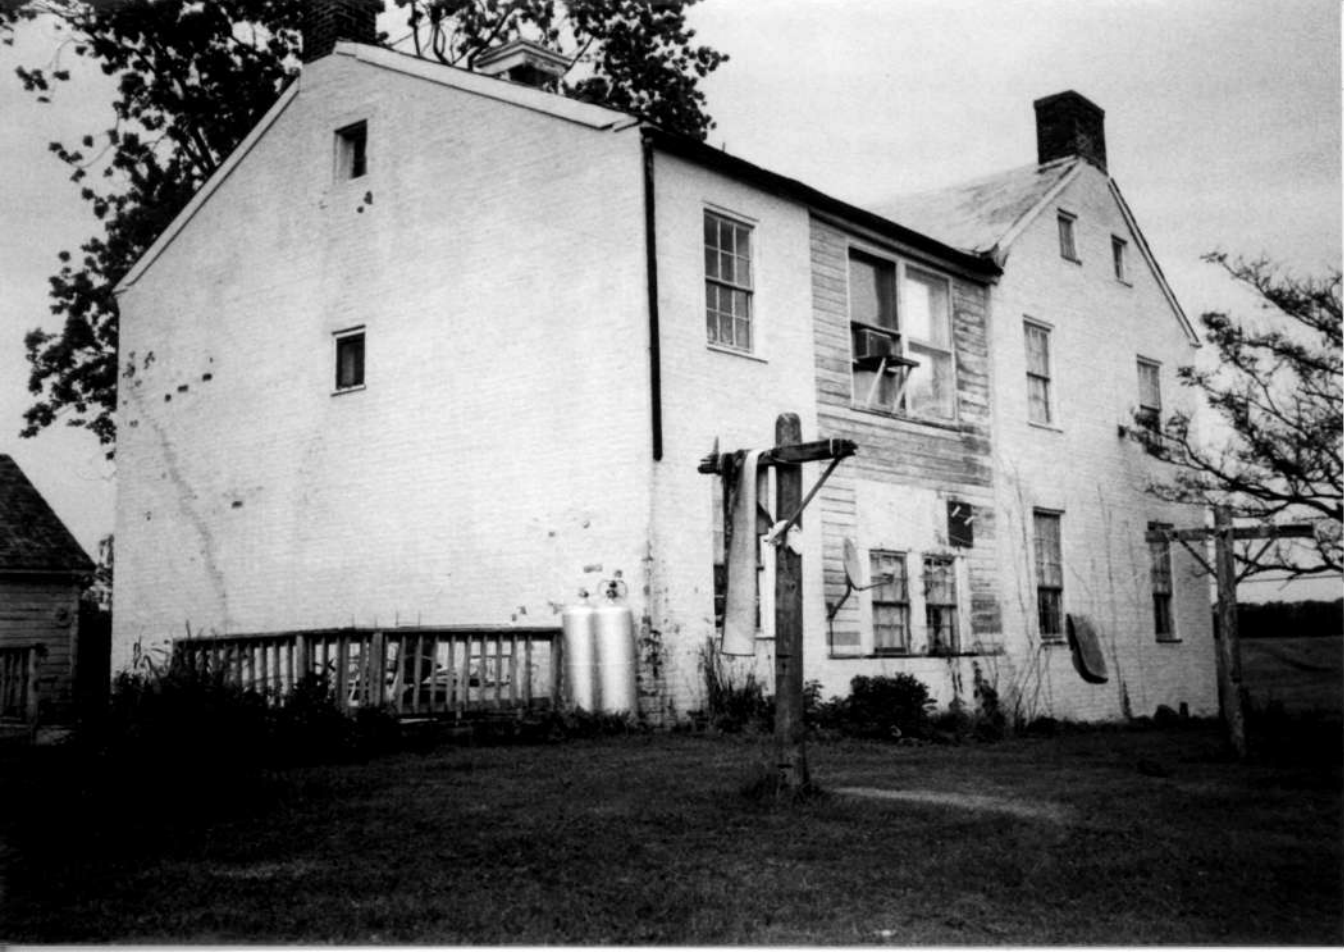
3/6

WORDEN - MAIN HOUSE, NORTH & WEST  
CARROLL CO., MD

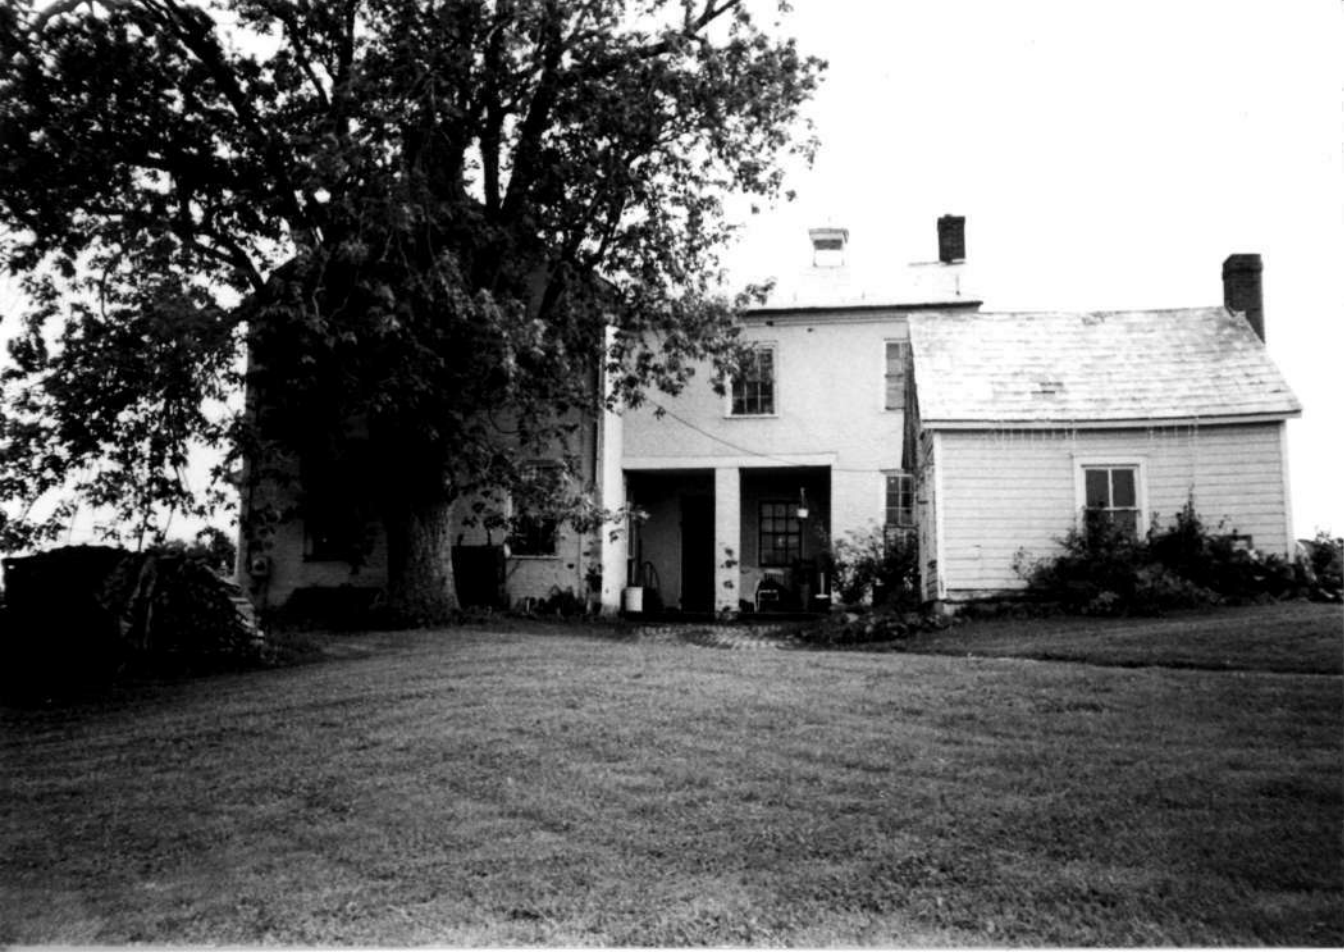
4/6

WORDEN - MAIN HOUSE & COTTAGE, EAST  
CARROLL CO, MD

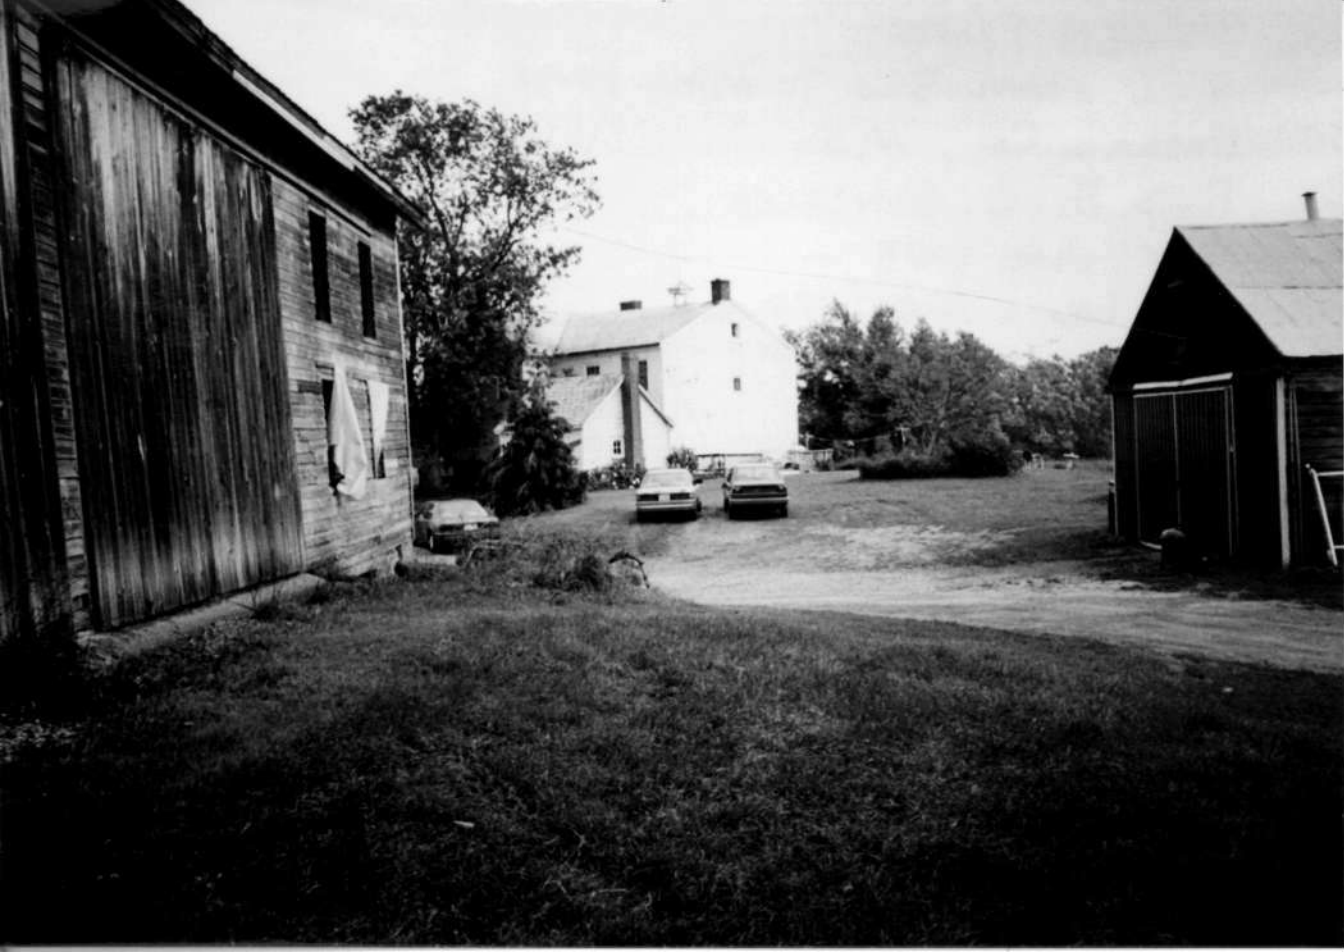
5/L

VIEW FROM SILO TO MAIN HOUSE
